At the Tip of the Spear

RED HORSE performs runway repair under cover of darkness

Lt Col Michael P. Skomrock
200th RHS

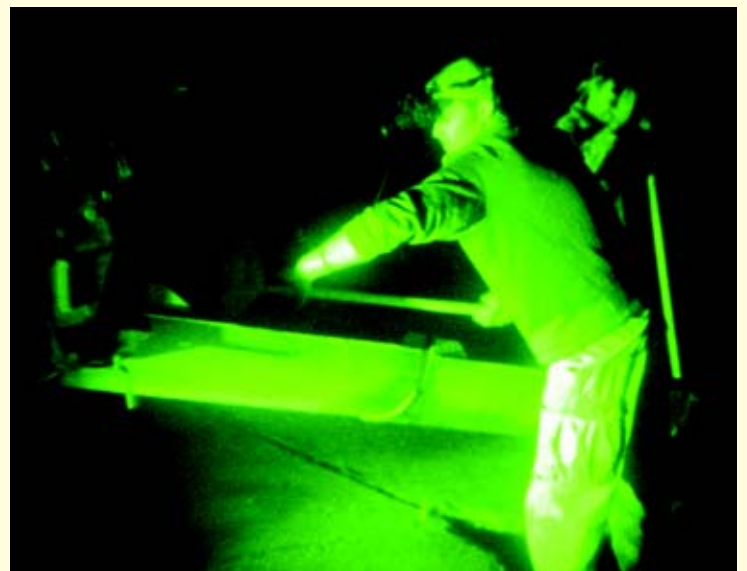
SSgt Scott McHugh, a heavy equipment operator, shovels concrete out of a chute during nighttime taxiway slab repair. (Photo by SSgt Bobby Yettman)

and increased the number of repairs needed to 504 slabs. As we progressed we identified additional slabs, bringing the final number to 628. We quickly geared up and expanded both manpower and schedule.
